DANISH MARITIME ACCIDENT
INVESTIGATION BOARD

SANTA CLARA

Marine accident report on occupational accident

7 FEBRUARY 2021

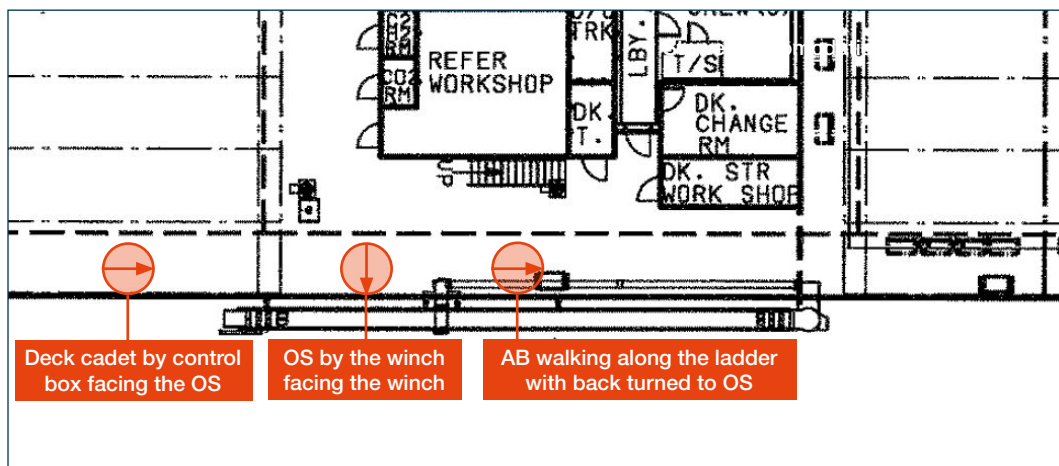
The course of events showed that the crew attempted to lower the accommodation ladder, but that it remained in its stowed position, until it suddenly fell down to its horizontal position. The reconstruction of events showed that the OS stood by the fall wire winch, the deck cadet stood by the remote control box, and the AB had his back turned to the OS and deck cadet (figure 5).

Figure 5: Location of AB, OS and deck cadet during the accident
Source: Mærsk Line/DMAIB

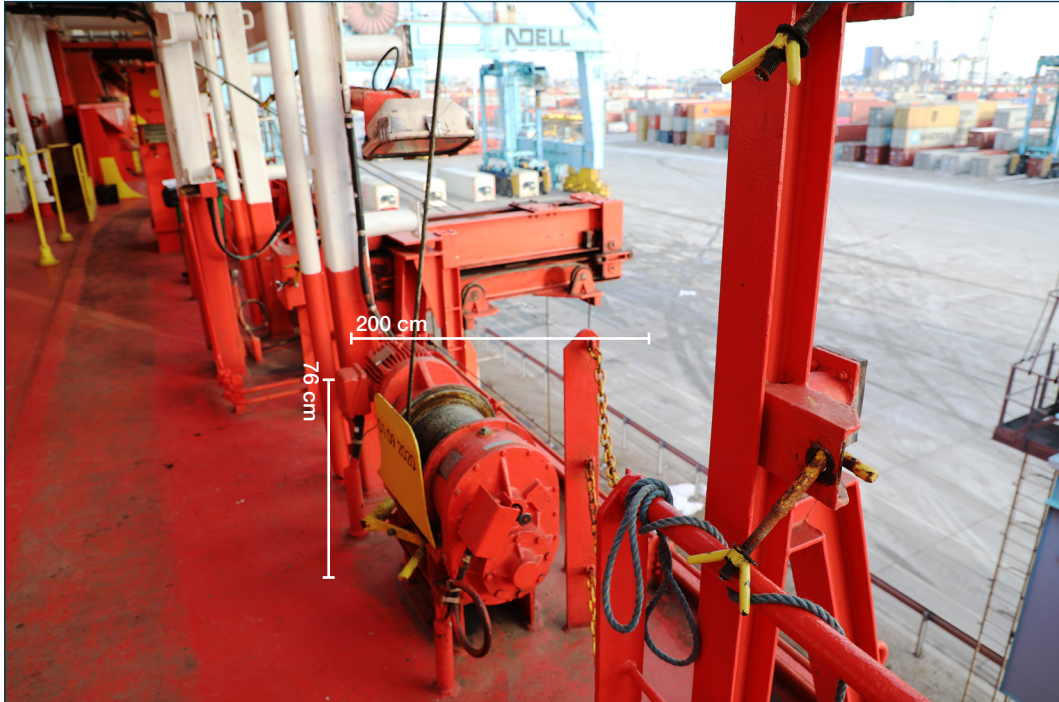
OS stood by the fall wire winch, and when the accommodation ladder was released, she was forcefully hurled 76 cm vertically over the winch and approximately two meters horizontally over the accommodation ladder before falling 17 meters into the sea (figure 6 and 7). There was no handrailing by the fall wire winch, so there was no barrier between the OS and the sea, when the OS was thrust over the ship's side (figure 8).

Figure 6: Site of accident
Source: DMAIB

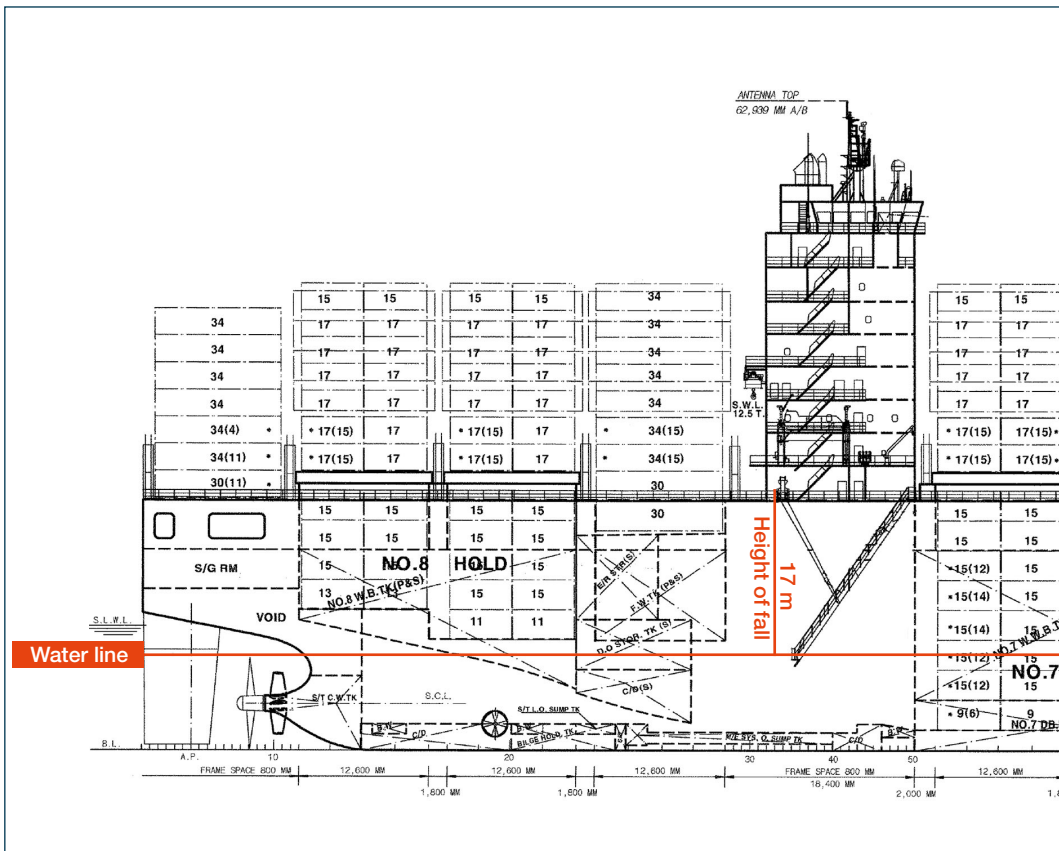
Figure 7: Height of fall
Source: DMAIB

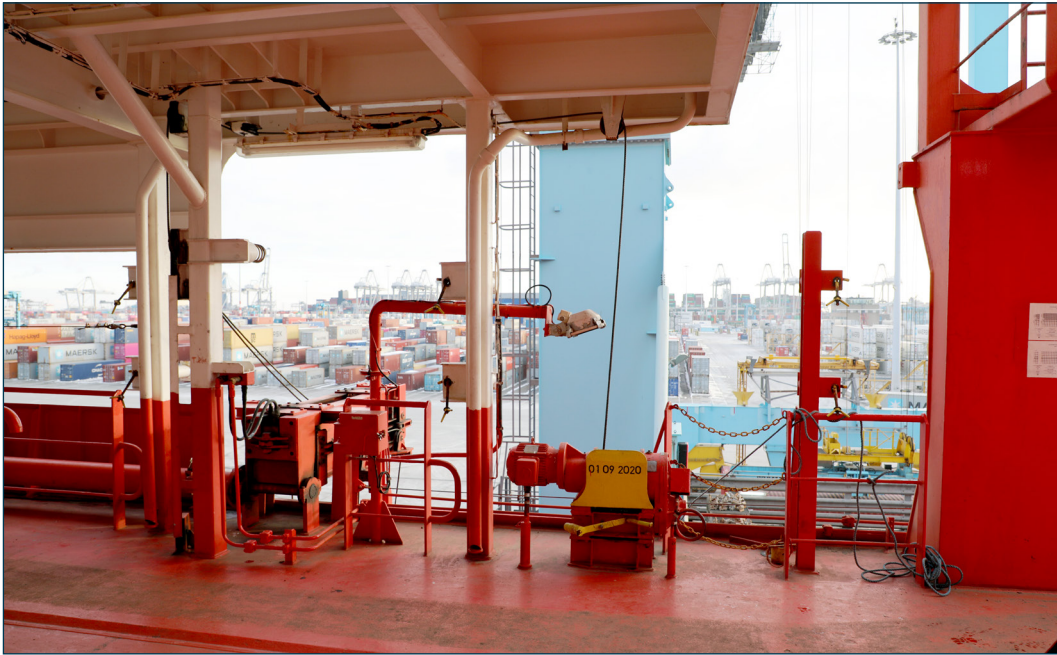
Figure 8: Gab in handrail by fall wire winch
Source: DMAIB

The result was that the force of the falling accommodation ladder was transferred to the wire and the OS, forcing her overboard. There was no railing mounted on the ship's side by the winch, which meant that only the winch stood between the OS and the edge of the upper deck. She fell 17 meters into the sea which had a temperature of 2°C. Under those circumstances, the OS's survivability was time critical.

- *The accommodation ladder installation on the Santa Class has been assessed resulting in extension of the railing design. Modification has been initiated for the vessel class (10 vessels in total).*
- *Decision has been taken to upgrade the on board personal protective equipment.*
- *Inflatable life jackets will be applied with personal locator (AIS) beacons.*
- *Test of light immersion suits for cold areas has been initiated and will be implemented for use in cold areas while working with high risk of falling over board e.g. when preparing the accommodation ladder.*
- *Emergency Flowchart (P822) for Man Overboard / Search & Rescue will undergo a review*
- *PMS activity for gangway check being reviewed – ensuring free movement of gangway.*

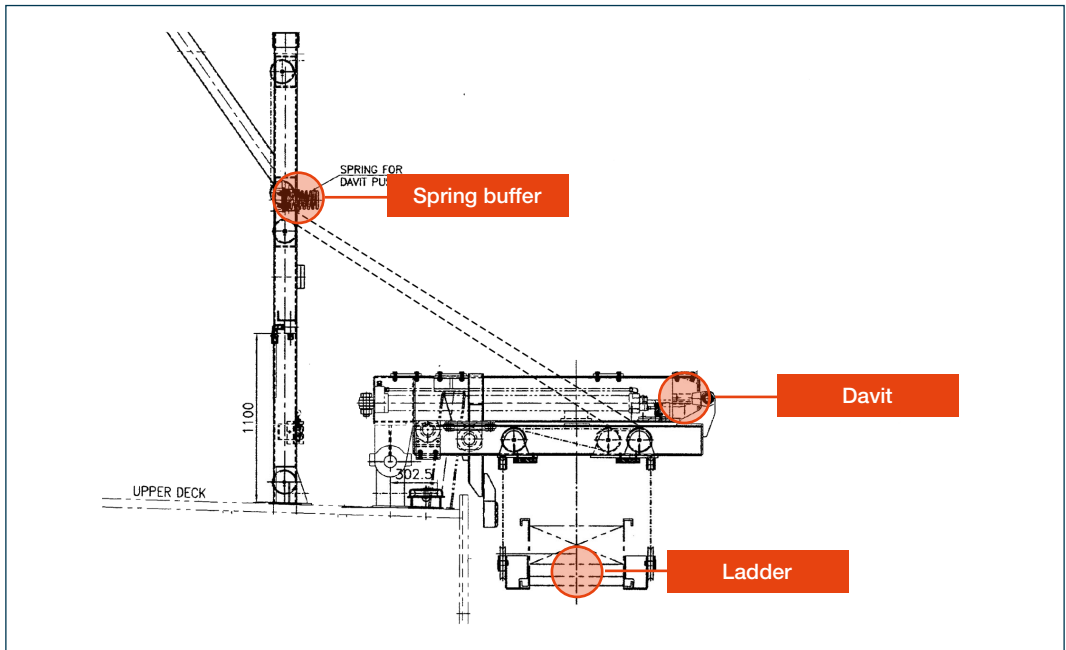
The initial focus was on the spring buffer, installed for the purpose of pushing the accommodation ladder outwards. On figure 13 below, the accommodation ladder is shown in its horizontal position, and the spring buffer can be seen on the upright frame (figure 14).

Figure 13: Buffer spring and accommodation ladder davit
Source: Mærsk Line/DMAIB

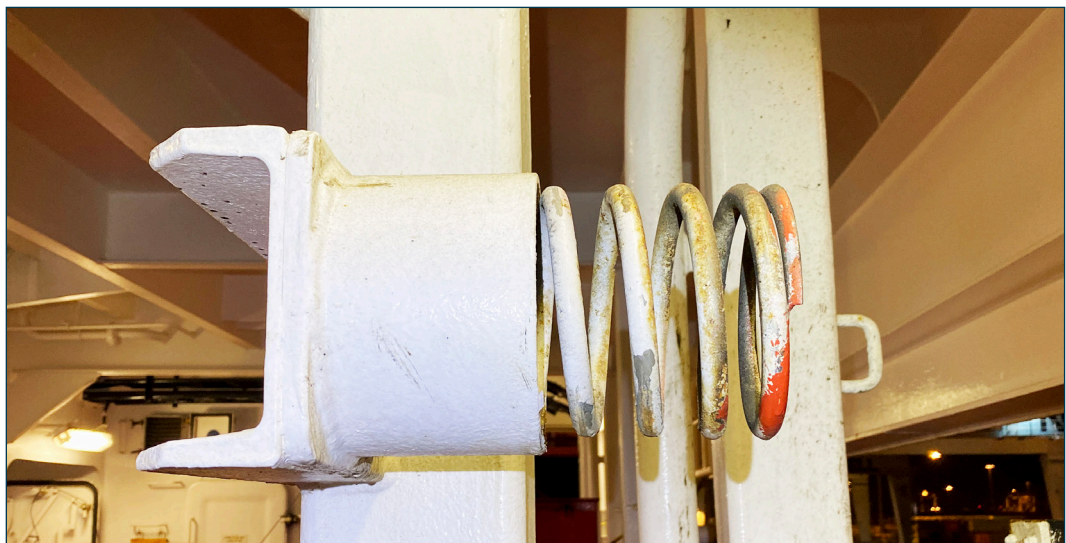
Figure 14: Buffer spring for davit
Source: DMAIB

The buffer spring was inspected, and no cracks or debris were found which would prevent it from functioning as intended. Measurements of the spring were compared with the values stated in the accommodation ladder system manual, and no discrepancies were found. Thus, the buffer spring was found to work as intended. Additionally, it was found that the ship was not listing to an extent that hindered the spring in pushing the ladder far enough out to be lowered.

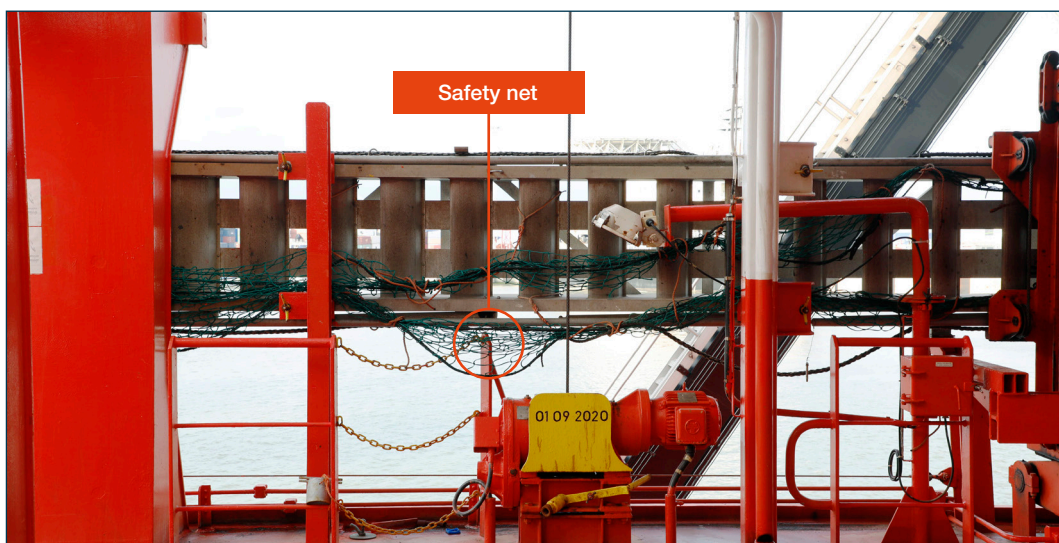
The accommodation ladder was permanently fitted with a safety net wrapped around the ladder and handrails (figure 15). The net could at times become entangled with the ladder frame, the bolt hooks, lashings, etc. It is, however, unlikely that the slack safety net could hold the weight of the ladder and counter the force of the spring buffer without the ladder moving.

Figure 15: Safety net on accommodation ladder
Source: DMAIB

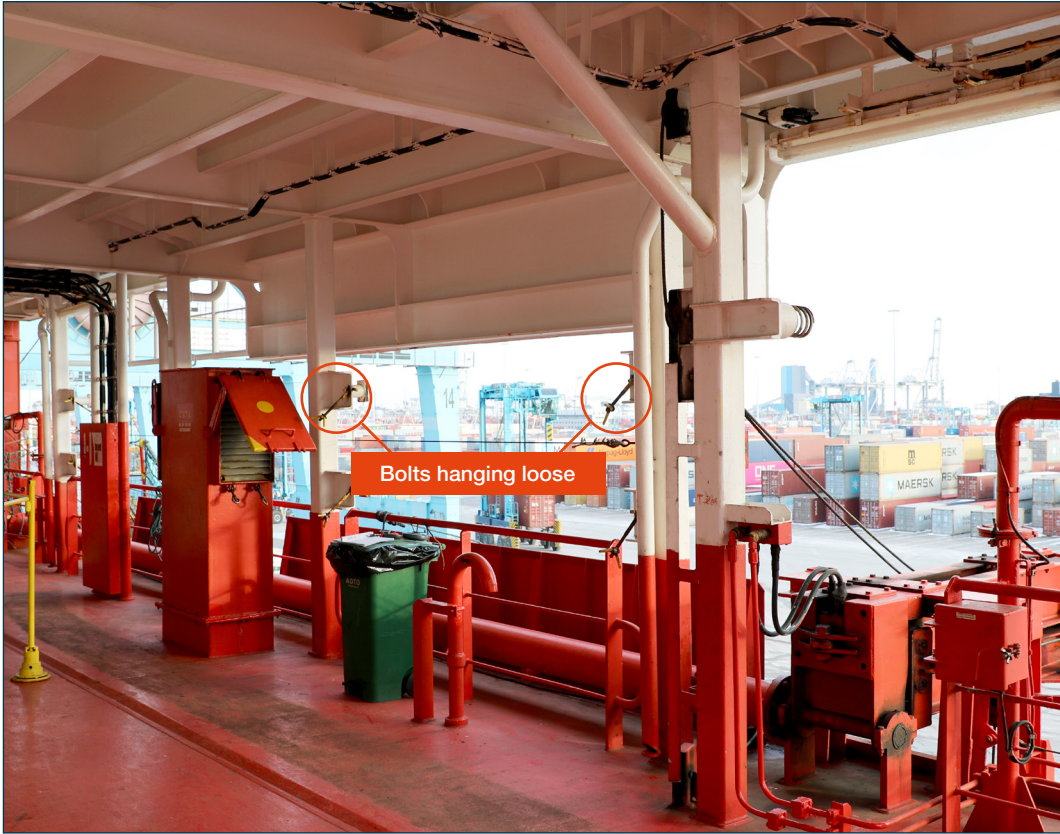
The bolt hooks were removed by the AB, OS and deck cadet before the fall wire winch for the accommodation ladder was activated. If one of the bolt hooks had not been fully removed, it could have held the ladder in its position. After the attempt to lower the accommodation ladder, the AB inspected the ladder to verify that all the bolt hooks were loosened and removed. It was readily visible for the AB to establish this, because the bolt hooks would hang as seen on figure 16 next page. The crew did not notice any of the hooks not having been loosened. During DMAIB's visit on the ship in Rotterdam, the wire fall and sheaves (figure 17) were inspected for signs of the fall wire slipping out of the sheave sockets. No part of the fall wire showed any abnormality nor did the sheaves.

Figure 16: Loose bolt hooks
Source: DMAIB

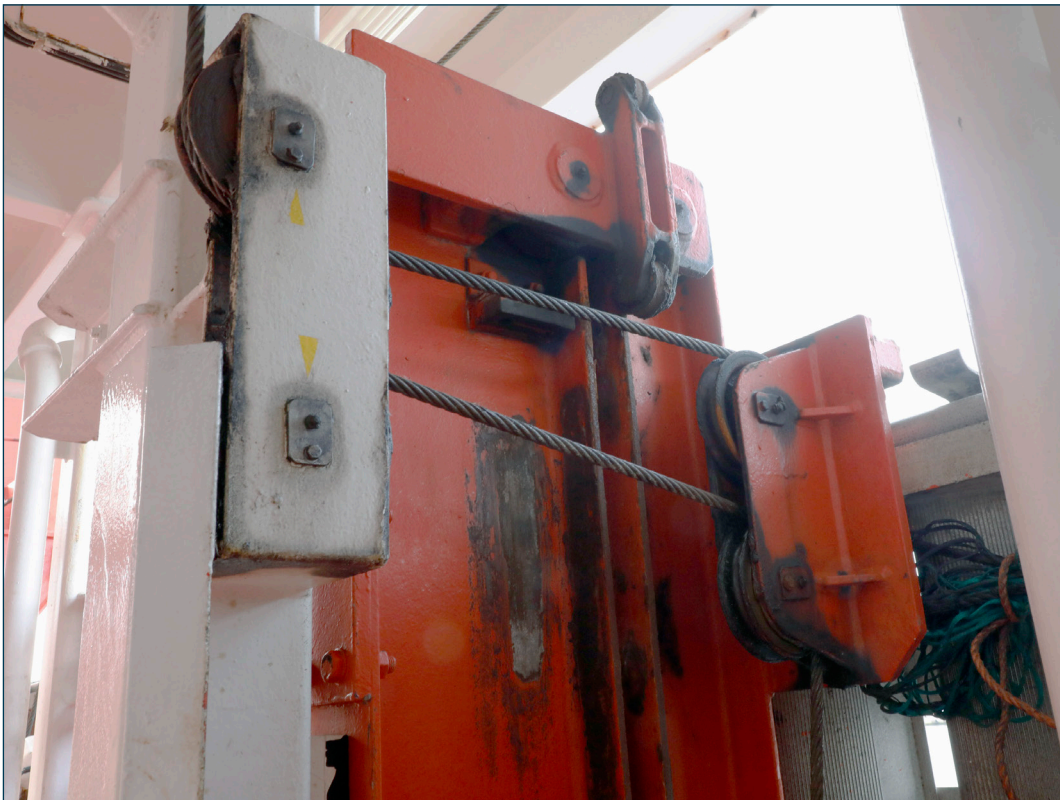
Figure 17: Fall wire and sheaves
Source: DMAIB

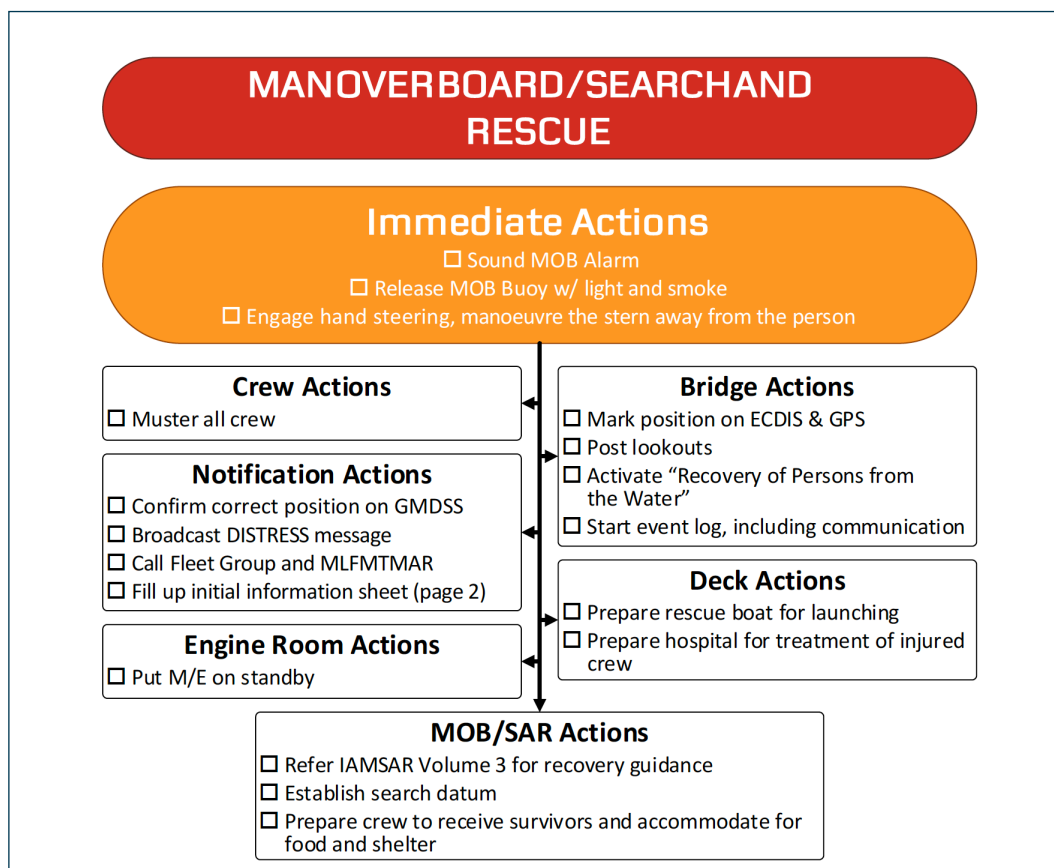
The flow chart was a checklist reminding the officers on the bridge of which actions to take immediately, and which actions were to be taken by other crewmembers. Some items on the list referred to specific actions to be taken, e.g. release the MOB buoy, whereas another item referred to wide-ranging actions, e.g. search and rescue actions according to the content of the IAMSAR manual (Vol III), which is a 250 page manual. When reviewing the content of the checklist, it is noticeable that the checklist is aimed at managing not only one person falling overboard, but also the retrieval of other persons from the sea.

On 7 February 2021, the crew on the bridge used the flow chart and considered it useful, but they also realised that the flow chart did not offer the appropriate action to the situation at hand – namely that the ship was not in open sea, but was navigating on a river under pilotage. Therefore, some of the proposed actions on the flow chart were relevant

Figure 20: Extract from man overboard flow chart
Source: SANTA CLARA

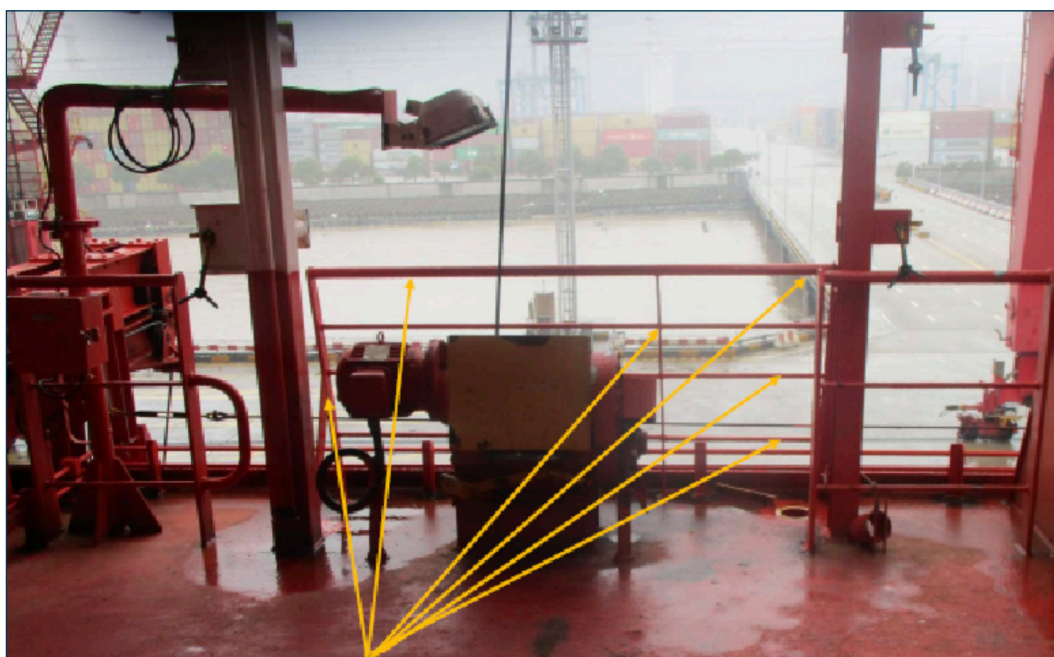
Figure 22: Railing installed after the accident
Source: MAERSK A/S
