DANISH MARITIME ACCIDENT
INVESTIGATION BOARD

SANTA CLARA

Marine accident report on occupational accident

7 FEBRUARY 2021

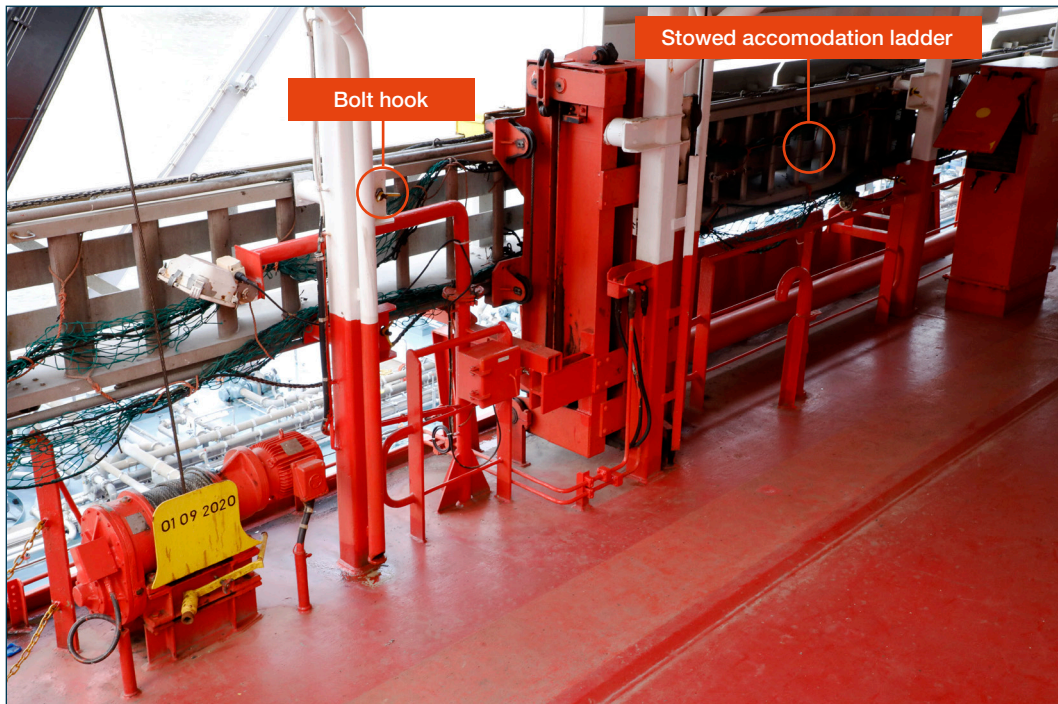
Figure 4: Accommodation ladder system in stowed position (port side)
Source: DMAIB

When the AB came back, the hook bolts had been removed, and the accommodation ladder was ready to be lowered. The AB told the deck cadet to go to the control station and lower the accommodation ladder. By the control station, the deck cadet pressed the button for lowering the accommodation ladder. But even though the fall wire holding the accommodation ladder in place paid out, the ladder did not lower. It was stuck. The deck cadet called out to the AB that something was wrong. After the AB had made several attempts to lower the accommodation ladder, the AB concluded that the accommodation ladder was somehow stuck, and that the fall wire had become slack. The AB was worried that the slack fall wire would become entangled on the winch, so he went to clear up the slack fall wire on the winch by hand.

Afterwards he went to the forward part of the accommodation ladder to see if he could identify the problem. As he walked forward, the OS went to the winch and held the slack wire. Suddenly, the accommodation ladder was released, fell down, and the wire was tightened instantly. From the control station, the deck cadet saw the OS being forcefully hurled overboard. The deck cadet immediately shouted "man overboard!", and the AB turned around and saw that the OS was missing. The time was 0339.

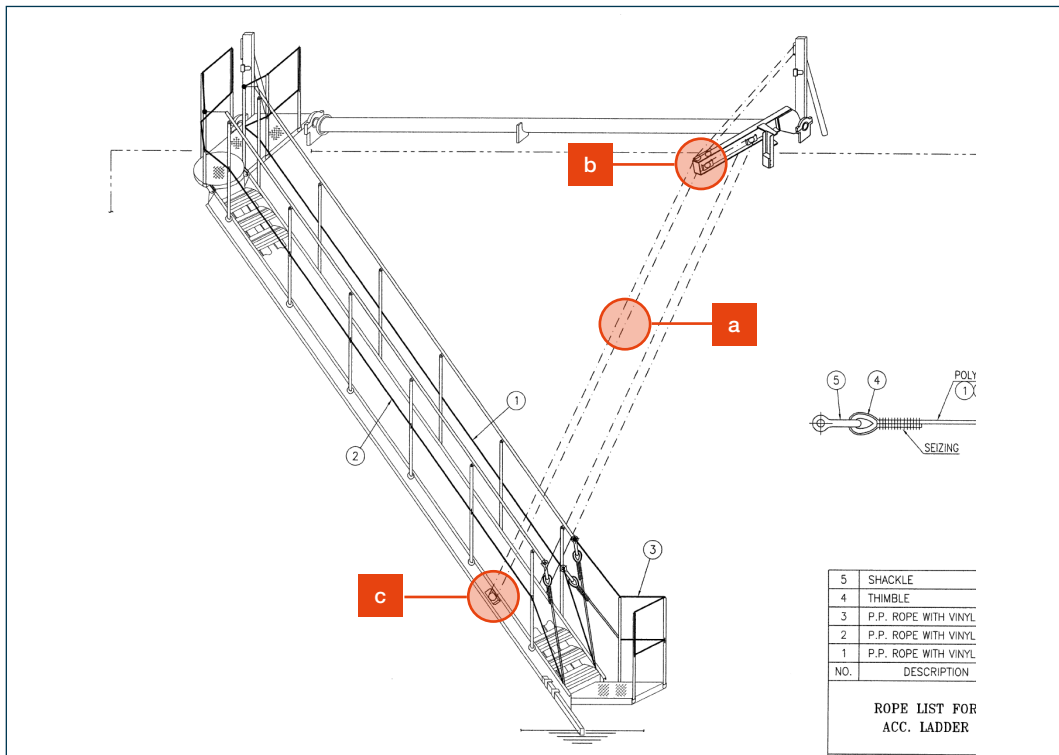
Figure 10: Accommodation ladder when lowered
Source: Mærsk Line/DMAIB

Figure 10 shows the system for lowering the accommodation ladder. The fall wire (a) led from the winch via a telescopic davit (b) down to a sheave (c) at the bottom end of the lower ladder section and along the lower ladder section to an anchor point (c) on the upper deck. This arrangement allowed the accommodation ladder to be lowered to its maximum inclination by paying out the fall wire.

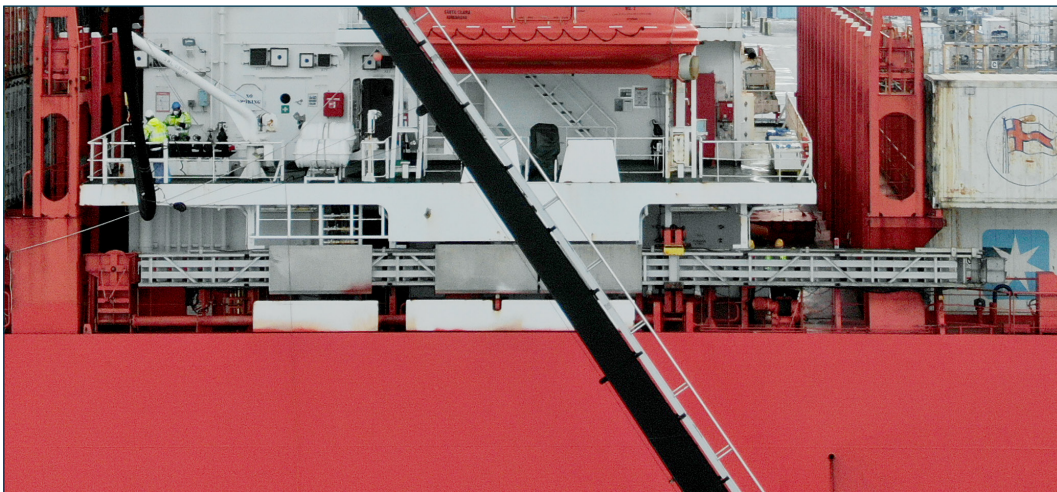
Figure 11: Accommodation ladder in stowed position
Source: DMAIB

For retrieving the accommodation ladder, hoisting the fall wire would retract the ladder by lifting it fully up to the telescopic davit at upper deck level. Continued hoisting of the fall wire would then lift the ladder to a horizontal position, 90 degree to its rigged position along the ship's hull (figure 11). A limit switch was activated once the ladder was in its place, cutting power to the winch, thereby preventing over-travel of the fall wire load which could result in the fall wire parting.

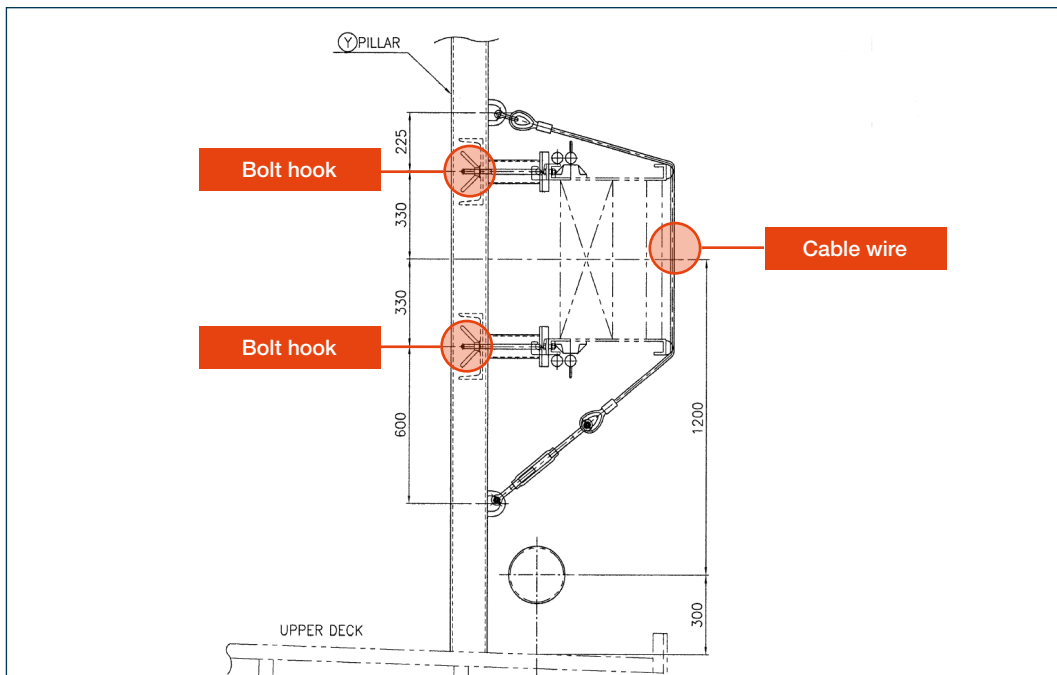
Figure 12: Accommodation ladder lashing
Source: Mærsk Line/DMAIB

Collapsible handrails were fitted to the upper and lower ladder sections. Portable stanchions with polypropylene man ropes were fitted around the upper and lower platforms. The collapsible handrails enabled the ladder to be stowed on its side on the upper deck. In stowed position it was lashed with bolt hooks and a cable wire securing it in place (figure 12).

When lowering the accommodation ladder, the bolt hooks and lashings were removed, and the winch control button was activated, paying out the fall wire which lowered the davit and accommodation ladder. On a steel frame holding the ladder, a spring buffer was mounted to push the ladder outwards, when the fall wire was paid out from the winch. After lowering the accommodation ladder, the handrails and the man ropes had to be manually secured in upright position by a crewmember standing outboards on the ladder.

The bolt hooks were removed by the AB, OS and deck cadet before the fall wire winch for the accommodation ladder was activated. If one of the bolt hooks had not been fully removed, it could have held the ladder in its position. After the attempt to lower the accommodation ladder, the AB inspected the ladder to verify that all the bolt hooks were loosened and removed. It was readily visible for the AB to establish this, because the bolt hooks would hang as seen on figure 16 next page. The crew did not notice any of the hooks not having been loosened. During DMAIB's visit on the ship in Rotterdam, the wire fall and sheaves (figure 17) were inspected for signs of the fall wire slipping out of the sheave sockets. No part of the fall wire showed any abnormality nor did the sheaves.

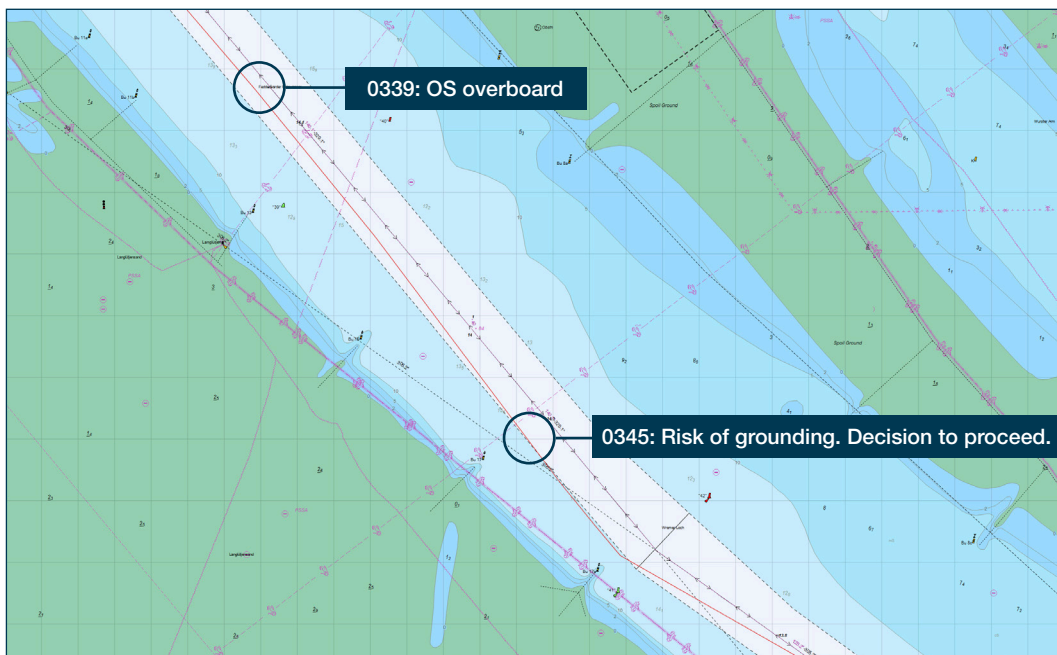
Figure 21: SANTA CLARA's position during the accident.
Source: © Made Smart Group BV 2021 © C-Map AS 2021

When the accident happened, the ship was en route on river Weser which was approximately 200 meters wide. At 0339, when the OS went overboard, the ship was proceeding at approximately 14 knots and within six minutes the ship had reduced the speed to approximately 7 knots. At this time the ship had travelled 1,800 meters and was positioned towards the southern limit of the channel (figure 21).

Six minutes after the accident, once the master realised that it would not be possible to hold the ship in place and that it was about to ground, it was decided to proceed towards Terminal Bremerhaven. In those six minutes, the master had to take the appropriate actions according to the flow chart while negotiating the conflict between stopping the ship and launching the rescue boat and grounding the ship. If the ship went aground, then the crew would be confronted with an additional emergency which would preoccupy the crew and rescue services, making it difficult to continue the search. Additionally, the operation of the rescue boat depended on being in the vicinity of SANTA CLARA, and it relied on the crew on SANTA CLARA keeping lookout and directing the rescue boat regarding where to go and look for the OS.

Under those circumstances, neither the design of the flow chart nor the planned operation of the rescue boat according to the drills could aid in resolving the situation at hand. The flowchart was made in line with industry standards and thus highlights how large merchant ships depend on shore-based rescue services when navigating in confined coastal waters.
